# Kilauea Lighthouse

Lighthouse restoration

Kauai, HI

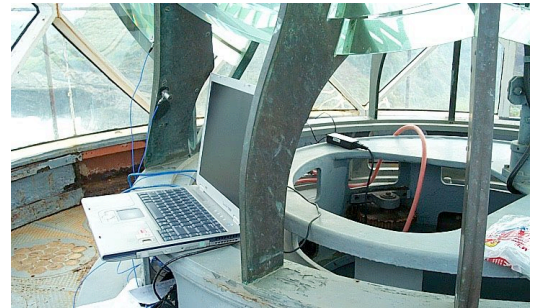
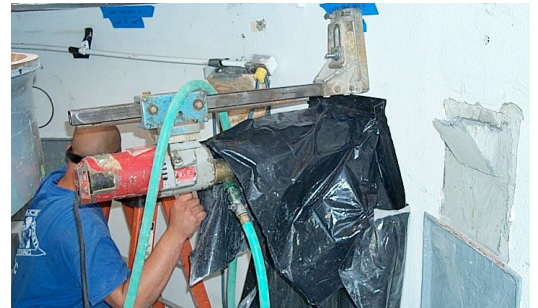
Kilauea Lighthouse began lighting the way for mariners in 1913, serving as a pivotal navigation aid for ships sailing to the Orient. Over the years, exposure to the saltwater coastal environment corroded the bolts connecting the central lighting mechanism to the concrete tower. While restoration commenced, it was also necessary to prevent vibration of the delicate and irreplaceable lens within the lighting mechanism, as well as to prevent waste from disturbing the delicate ecology at Kilauea Point.

- Wall-mounted a coring rig within the lighthouse structure
- Cored through the wall to remove the end of each bolt, and then pulled the remaining threaded rod out from above
- Installed new stainless steel rods and mortared the bottom to conceal where the core had been removed
- Installed vibration monitoring equipment and isolation bumpers under the light mechanism, and followed a strict procedure of bolt replacement designed by the architect to prevent vibration of the lens
- As always, ensured that excess material was disposed of properly, with no disturbance to the surrounding wildlife refuge in this case
