PARKING GARAGES

Coralville Town Center

Bonded Overlay for Municipal Parking Garage

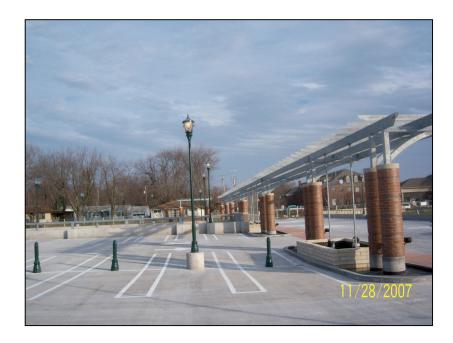
An error made in placing the top mat of reinforcing in a newly completed parking garage slab resulted in visible cracking in the surface of the slab and a reduced design capacity. Remedial work required Zera Construction to shore, remove and replace the upper 6" of the slab in order to reset the steel and correct the problem.

- Structurally shored the structural slab at 10' on center
- Used hydrodemolition to remove 70,000 SQFT of concrete
- Removed 6" of concrete to release the upper mat of steel
- Paving sequence was performed in six phases using a 170' boom pump truck to place 1,300 cubic yards of concrete and to deal with difficult logistical issues
- Rebuilt planter boxes and re-established an intricate curb layout
