# Kilauea Lighthouse

Lighthouse restoration

Kauai, HI

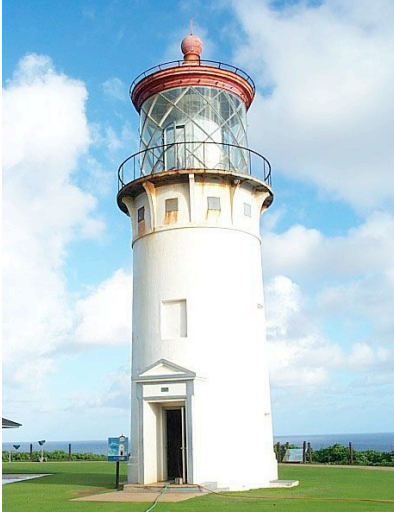
Kilauea Lighthouse began lighting the way for mariners in 1913, serving as a pivotal navigation aid for ships sailing to the Orient. Over the years, exposure to the saltwater coastal environment corroded the bolts connecting the central lighting mechanism to the concrete tower. While restoration commenced, it was also necessary to prevent vibration of the delicate and irreplaceable lens within the lighting mechanism, as well as to prevent waste from disturbing the delicate ecology at Kilauea Point.

- Wall-mounted a coring rig within the lighthouse structure
- Cored through the wall to remove the end of each bolt, and then pulled the remaining threaded rod out from above
- Installed new stainless steel rods and mortared the bottom to conceal where the core had been removed
- Installed vibration monitoring equipment and isolation bumpers under the light mechanism, and followed a strict procedure of bolt replacement designed by the architect to prevent vibration of the lens
- As always, ensured that excess material was disposed of properly, with no disturbance to the surrounding wildlife refuge in this case
