STADIUMS, HISTORIC LANDMARKS

Notre Dame Stadium

Replaced Structural Concrete Topping Slab of a College Stadium

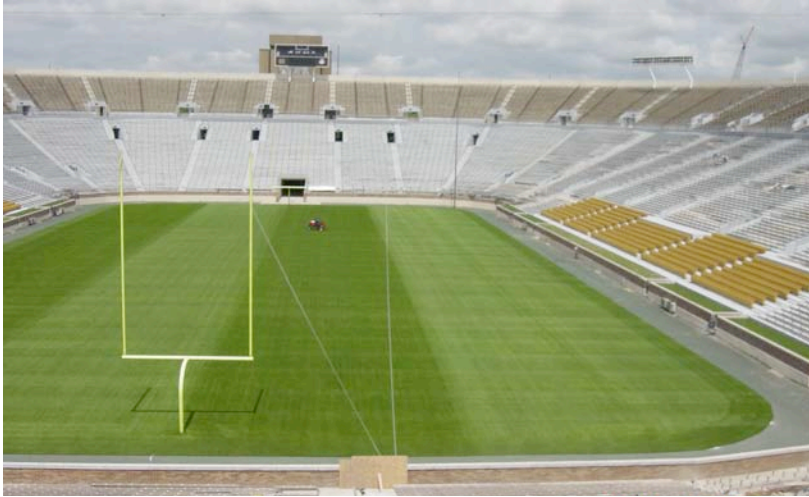
After 70 years of football in this historic, 80,000 seat stadium, concrete renovations were badly needed. One quarter million square feet of surface topping slab required removal by jackhammer and Bobcat only, due to weight restrictions. All work had to be completed during the football off-season.

- Ensure a well-bonded concrete overlay through surface preparation, consisting of surface milling and shotblasting
- Installed a Neogard traffic-bearing waterproofing membrane with Watson Bowman expansion joints
- Installed over 100 new cast-in-place concrete shear walls to reinforce old and new bowls
- Completed all work on-time and on-budget, and found creative ways to reduce expenses on this cost-plus project
- Delivered on the promise of negotiating this complex, high profile project effectively, and demonstrated the integrity and scheduling thoroughness that won the project initially
